**INSTALLATION & MAINTENANCE MANUAL  
for Composite Tail Rotor Blade  
Part Number AMT-206-1  
Supplemental Type Certificate SVR 520**

**Tail Rotor Blade AMT-206-1**

Document No. **CTRB-IMM**

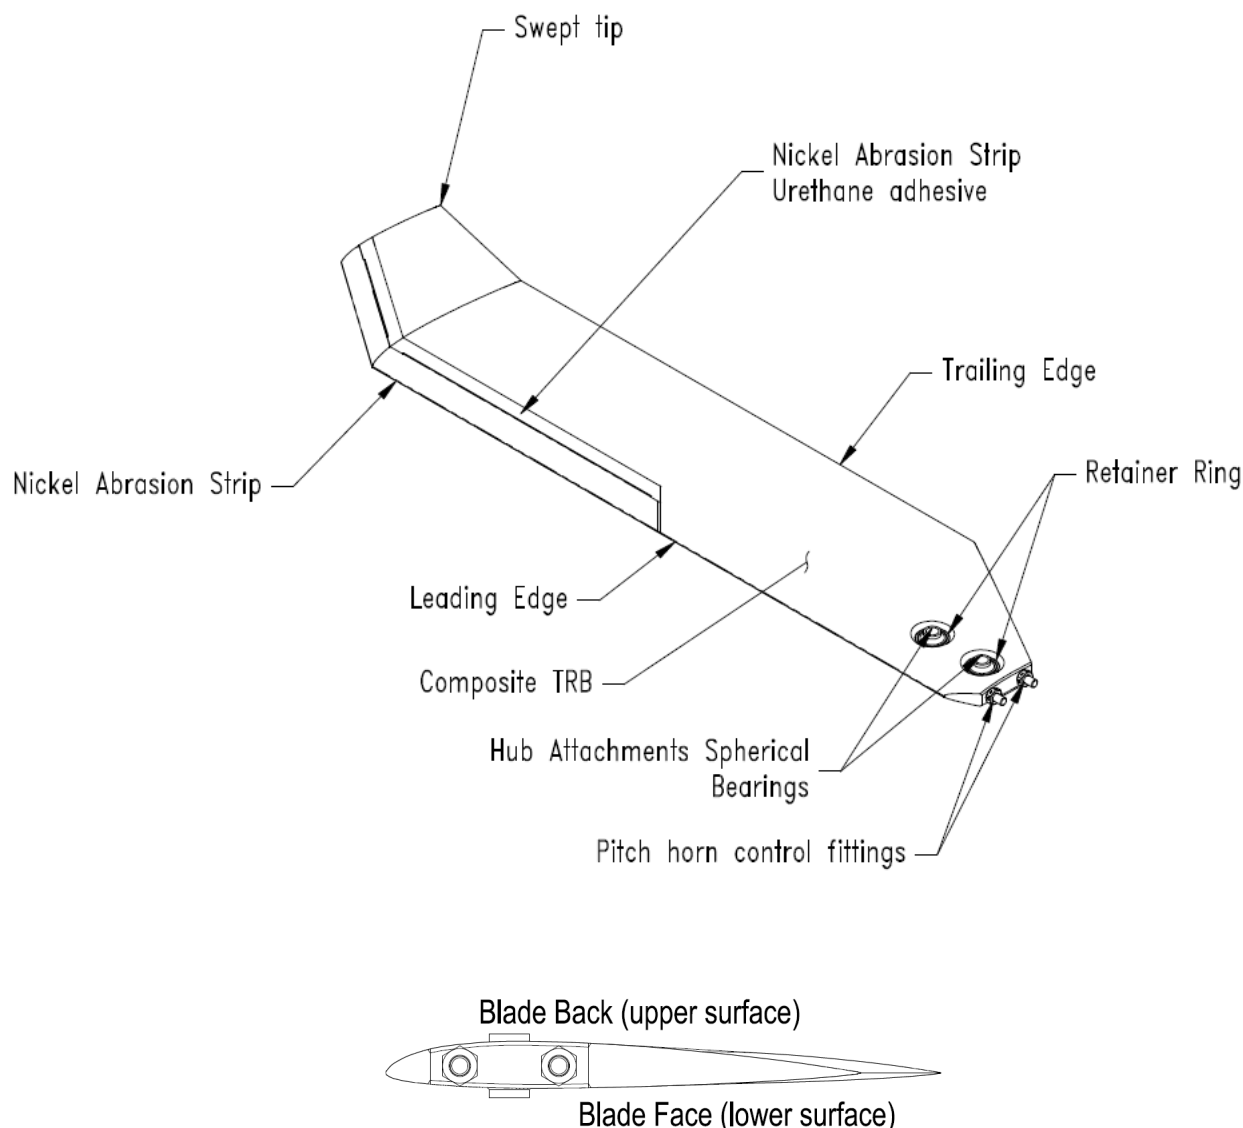
**Figure 1 – Blade Overview**

The AMT-206-1 composite tail rotor blade is direct replacement for the Bell 206 TRB. The AMT-206-1 TRB has a non-symmetrical airfoil section and incorporates a swept tip. The blade is primarily fabricated from uni-directional Graphite and Aramid continuous fibres suspended in an epoxy matrix and is fitted with a nickel abrasion strip on the leading edge. The abrasion strip is bonded on using a urethane adhesive.

The AMT-206-1 tail rotor blade is designed around a mix of aramid, carbon and glass fibres that are bound in an epoxy matrix. The design incorporates a stainless steel mesh embedded in the surface coat to provide lightning protection

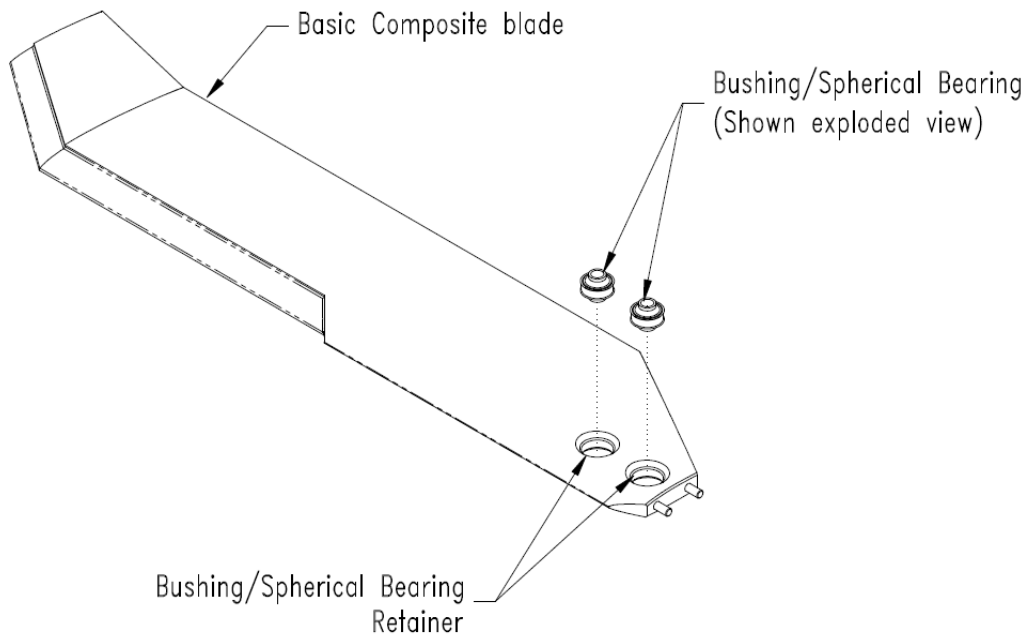
**Figure 4 – Spherical Bearings (Blade Installation)**

The blade is fitted with two HAC-SSW Spherical Bearings which permit the blade pitch angle to be adjusted. The two Spherical Bearings are NOT field replaceable and may only be replaced by the factory (A.M.T. Helicopters Pty Ltd) using procedures and tooling approved by A.M.T. Helicopters Pty Ltd.
